LITTLE COLORADO RIVER BASIN ARIZONA-NEW MEXICO

APPENDIX III EROSION & SEDIMENT AND FLOODING

December 1981

LITTLE COLORADO RIVER BASIN
COOPERATIVE STUDY

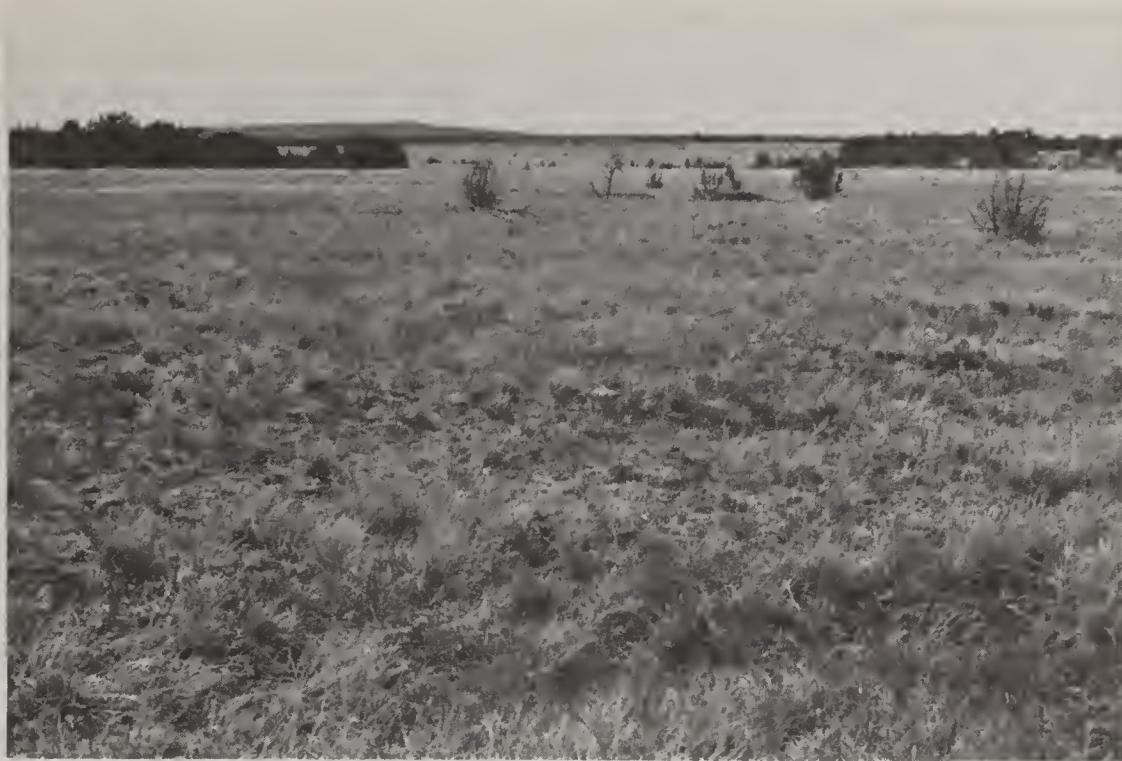
Photo 1-1: Rangeland with low erosion rate, Navajo County, Arizona. Good grass cover is responsible for low erosion rates.

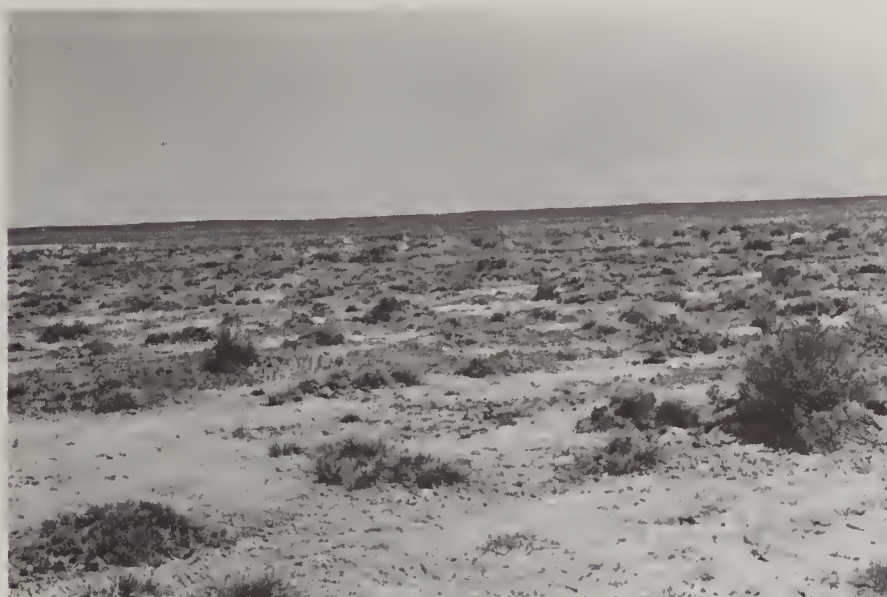
Photo 1-2: Rangeland in Navajo County, Arizona undergoing severe sheet and rill erosion.

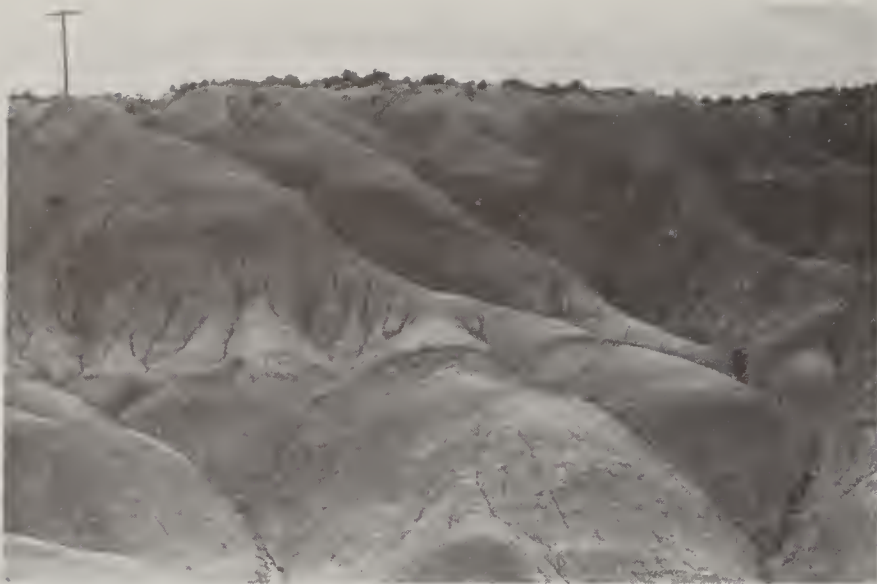
Photo 1-3: Severely eroding badland area in Apache County, Arizona. Note lack of vegetative cover.

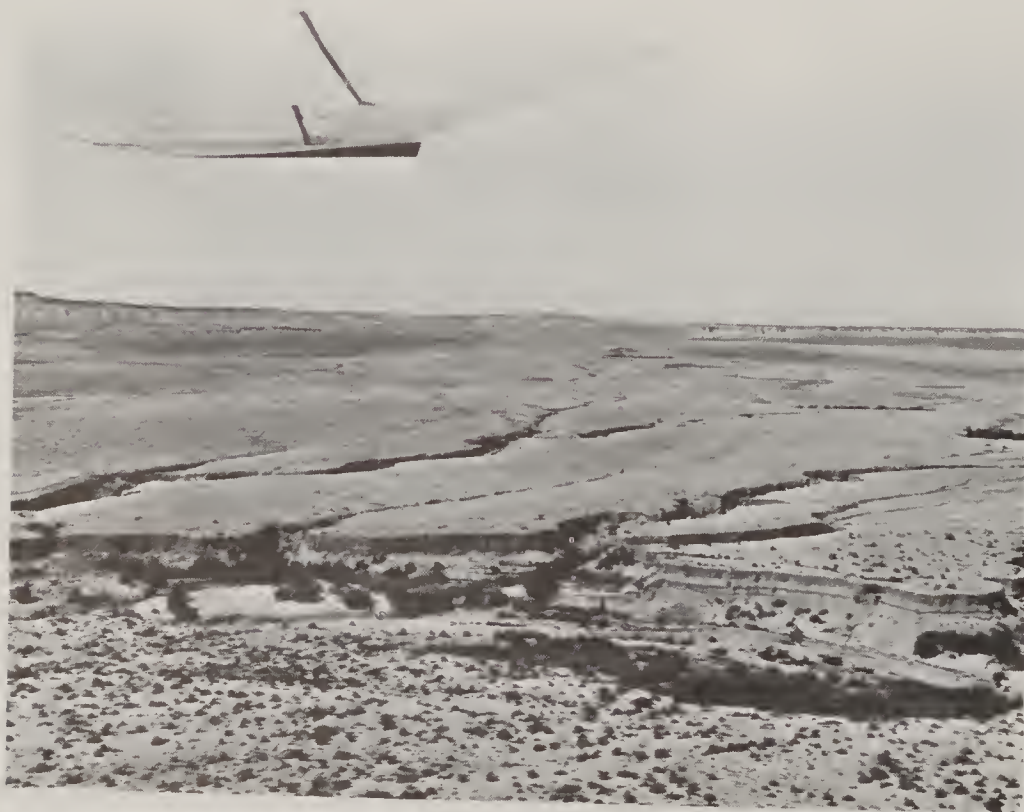
Photo 1-4: Severe gullying of alluvial valley in Apache County, Arizona.

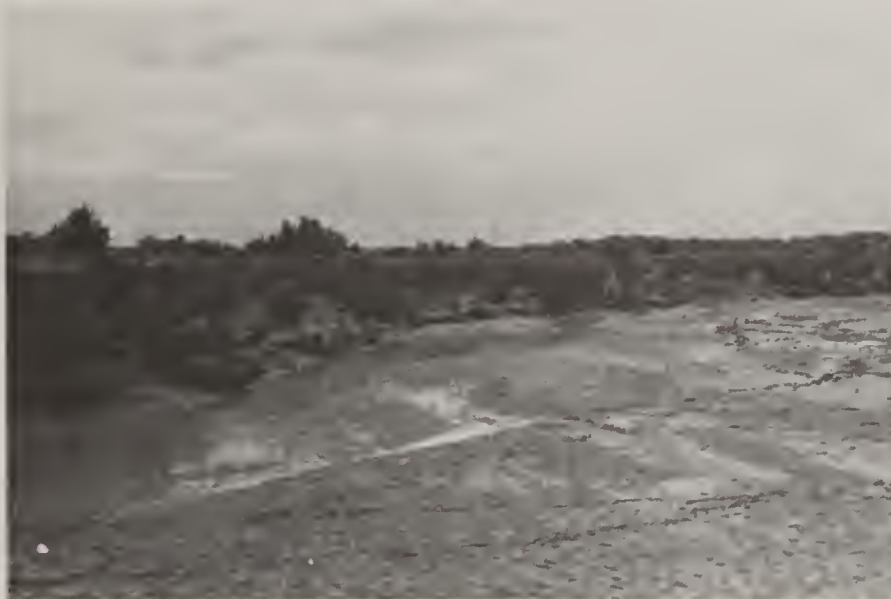
Photo 1-5: Severe streambank erosion, Puerco River, Apache County, Arizona.

Locally, streambanks are undergoing severe erosion. In many areas, gully erosion is rapidly eroding areas adjacent to the river banks (Photo 1-5). Piping (the movement of soil particles by percolating water leading to the development of channels) is a problem on many of the soils. The collapse of soil overlying erosional pipes frequently leads to the development of large gullies (Photo 1-6).

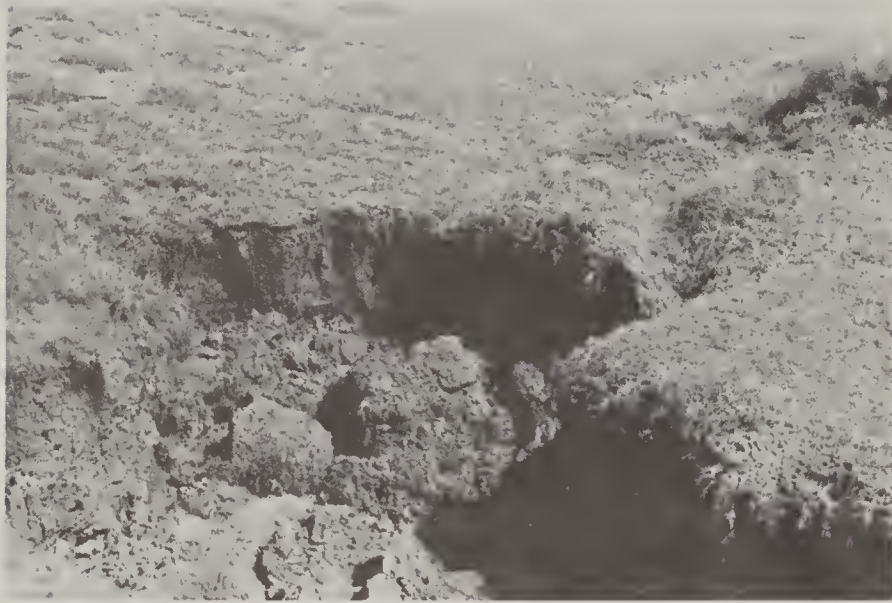
Photo 1-6: Gully developed through piping erosional process in Zuni River Valley, Apache County, Arizona.

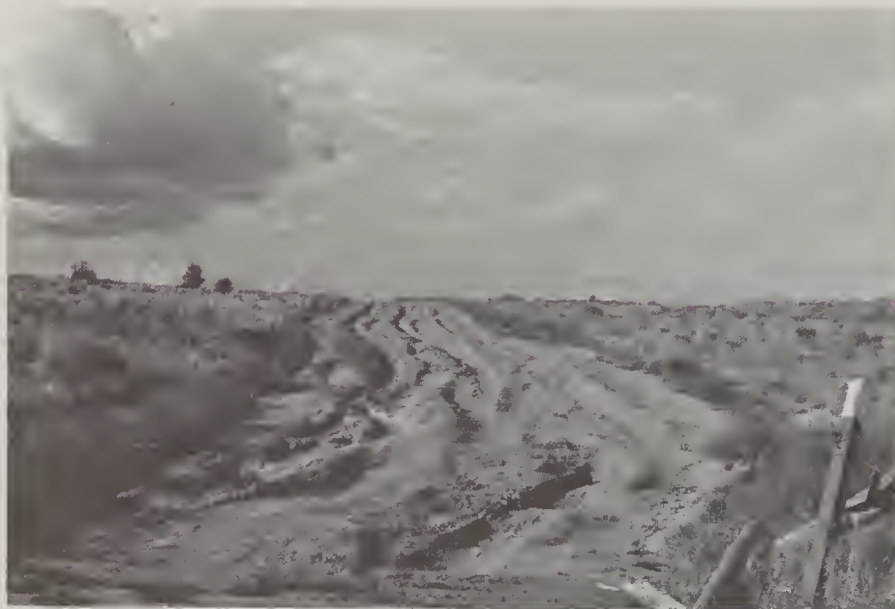
Photo 1-7: Eroding road on Navajo Indian Reservation, Apache County, Arizona.

Significant erosion of roadways occurs in parts of the Basin. There are many miles of unimproved dirt roads on the Indian reservations. These roads are often located with little regard for topographic or soil conditions. Many roads are abandoned, and new ones are made when they become impassable due to muddy conditions or when gullies form (Photo 1-7). There are also erosion problems associated with road cuts along improved roads. An example of such problems is seen on Highway 180 between Holbrook and St. Johns and intermittently throughout much of the Basin (Photo 1-8).

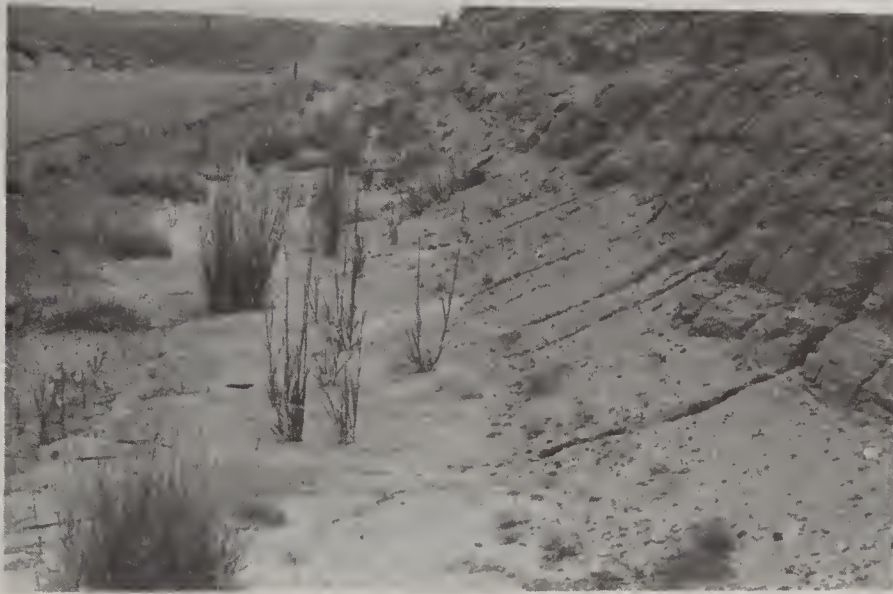
Photo 1-8: Eroding road bank in Apache County, Arizona.
Note sediment deposition in ditch.

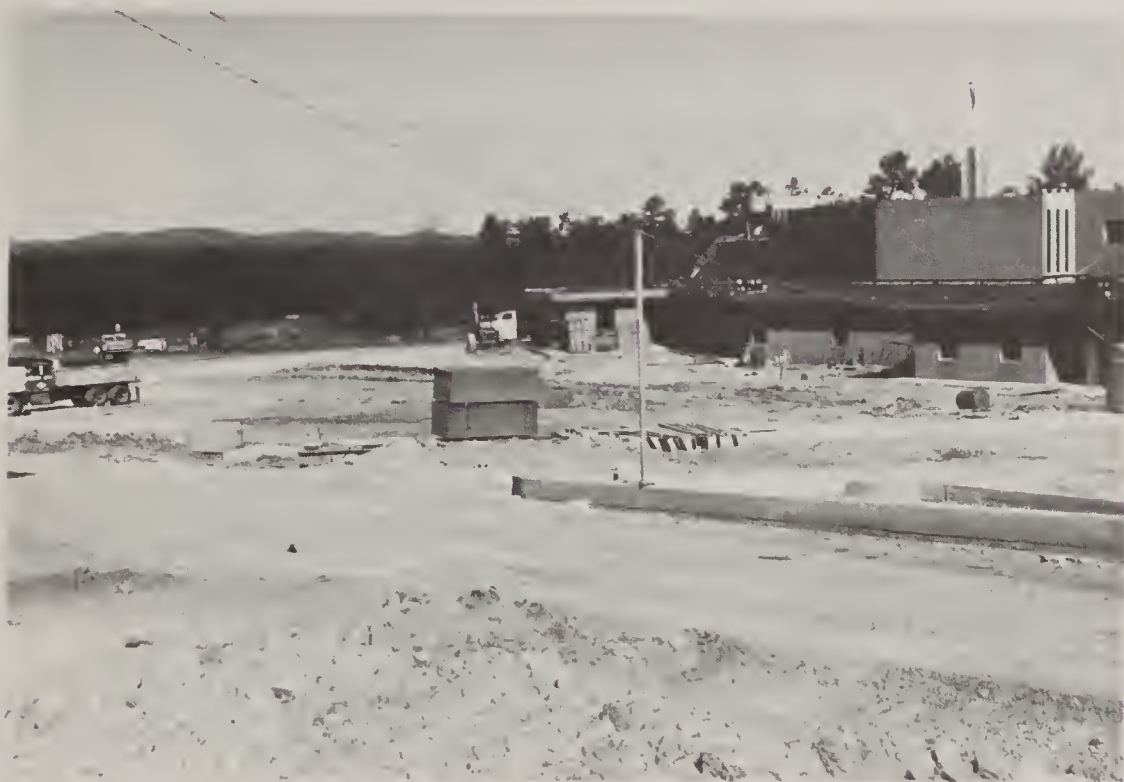
Photo 1-9: Construction site at Show Low, Arizona, showing
bare, disturbed soils subject to high erosion rates.

Generally, construction sites are areas with high erosion rates (Photo 1-9). These relatively small areas may undergo excessive erosion during construction operations. This excessive erosion rate is many times the average annual rate prior to the disturbance. While not considered a serious problem at this time, erosion on construction sites may intensify as parts of the Basin experience increased development. Careful planning of construction activities and installation of practices to control erosion and runoff from construction sites can greatly reduce this problem (Photo 1-10). Erosion may continue to occur at high rates if permanent erosion control measures are not included in the landscape design (Photos 1-11 and 1-12).

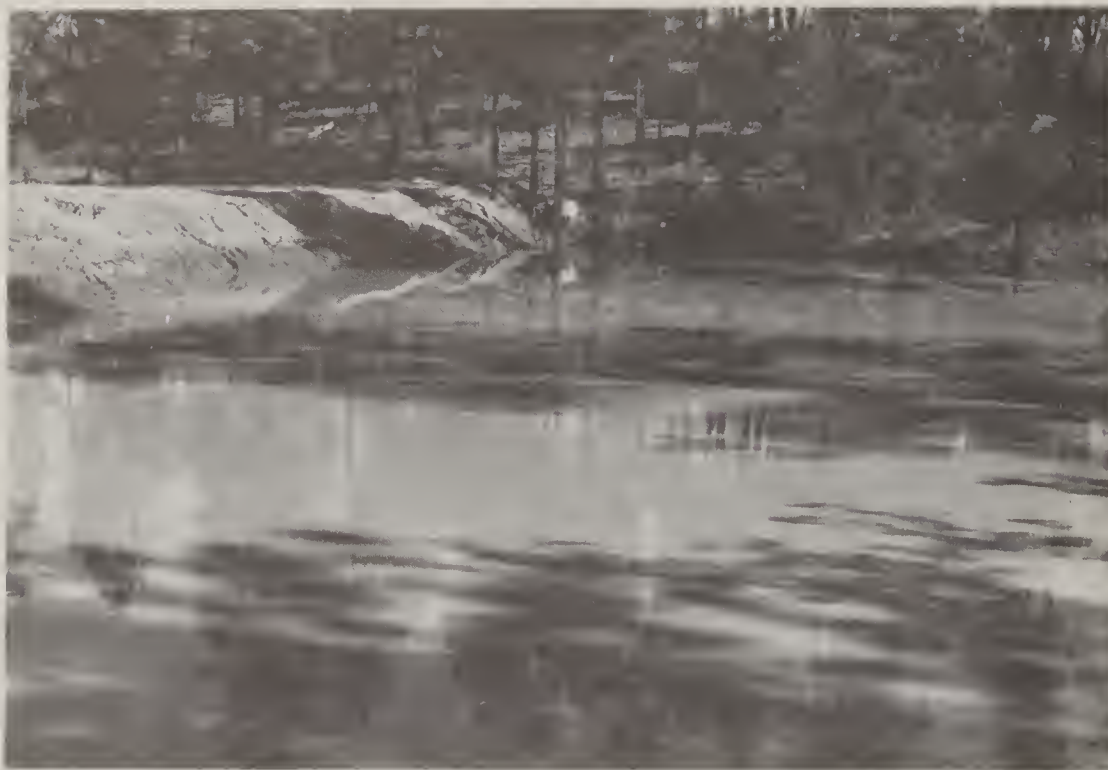
Photo 1-10: Sediment retention basin to store sediment from construction site shown in Photo 1-9.

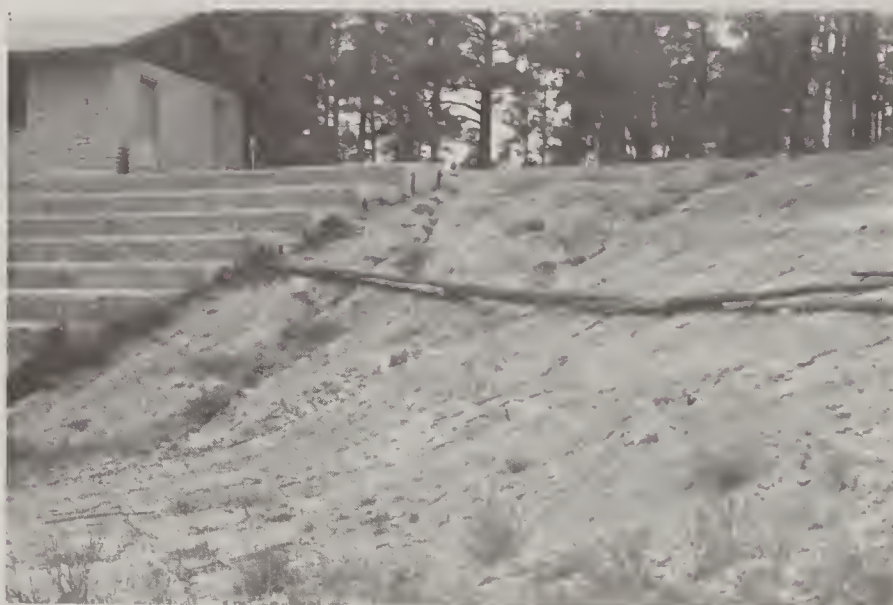
Photo 1-11: Unprotected cut slope at ball field at Show Low, Arizona, showing high rate of erosion.

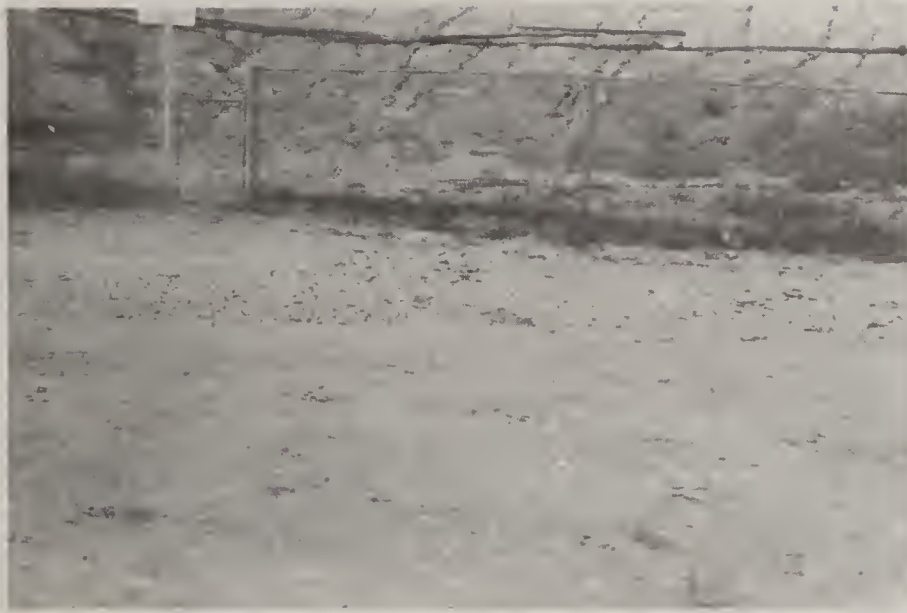
Photo 1-12: Sediment deposited on playing area of ball field from slope shown in Photo 1-11.

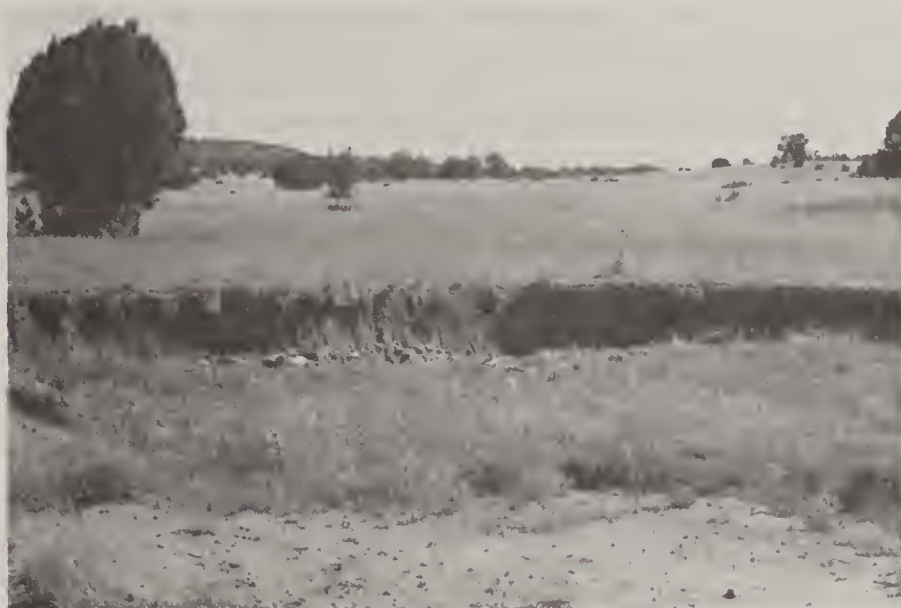
Photo 1-13: Headcutting gully destroying good rangeland in Apache County, Arizona.

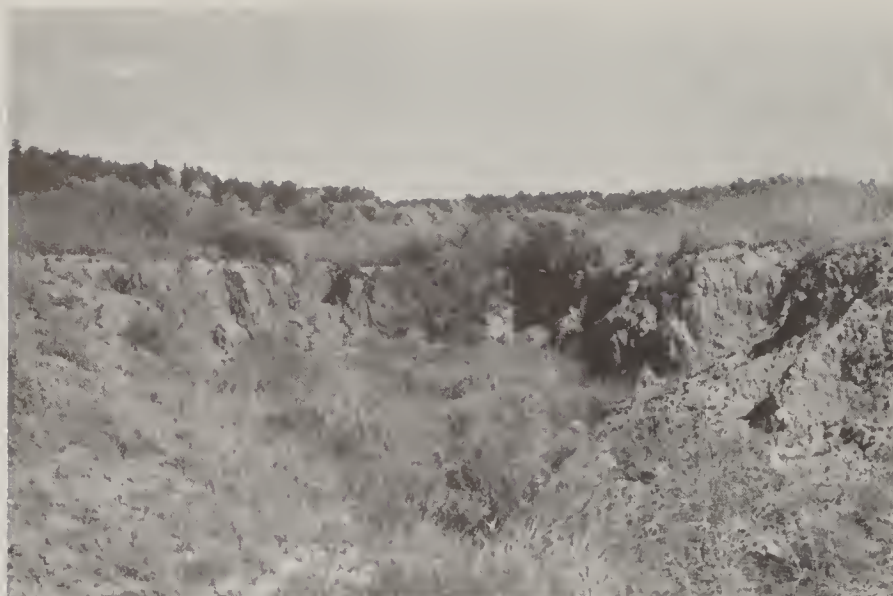
Photo 1-14: Headcutting gully in small valley, Navajo County, Arizona.

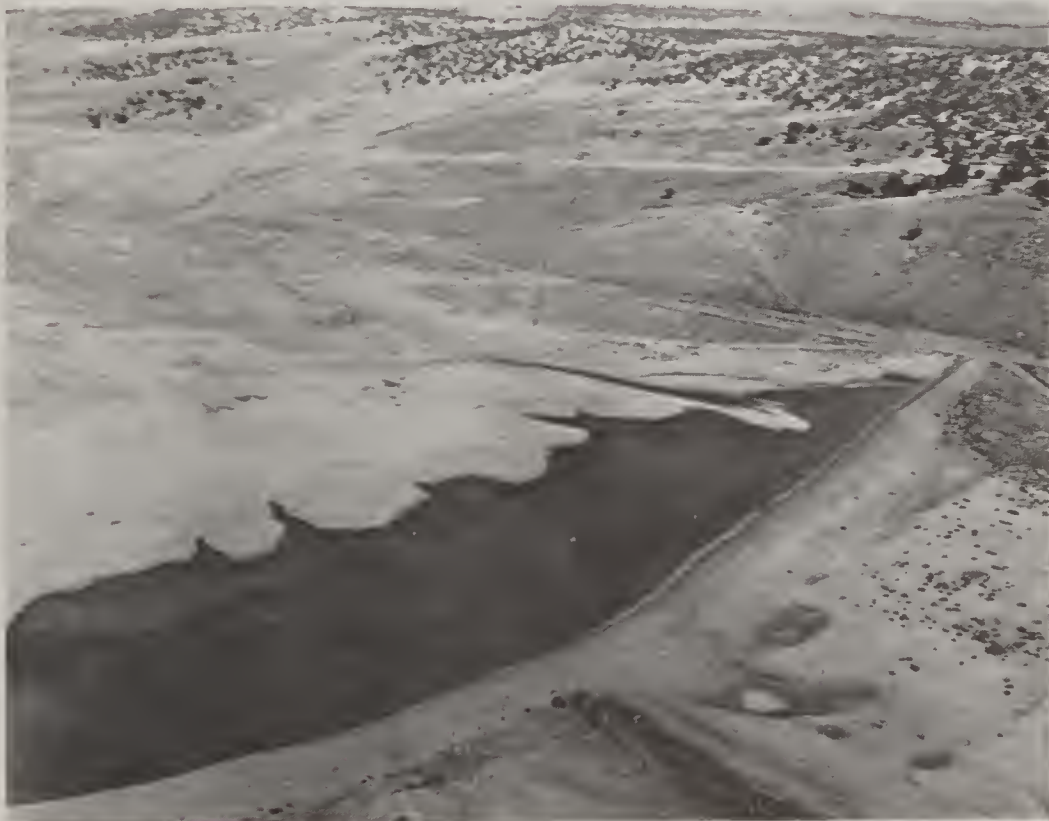
Photo 1-15: Reservoir storage capacity has been severely reduced due to sediment filling of this Navajo County, Arizona reservoir.

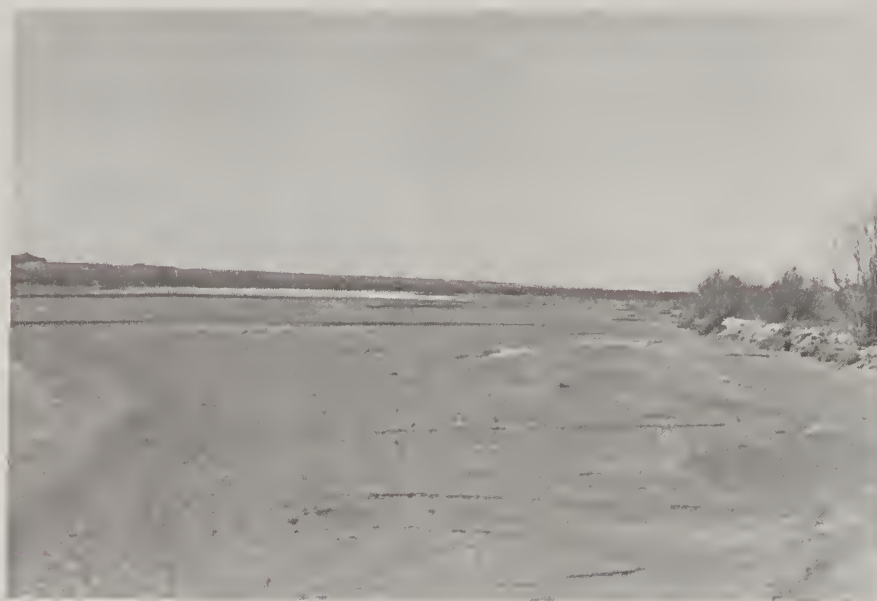
Photo 1-16: Channel of Little Colorado River nearly completely filled with sediment near Joseph City, Arizona.

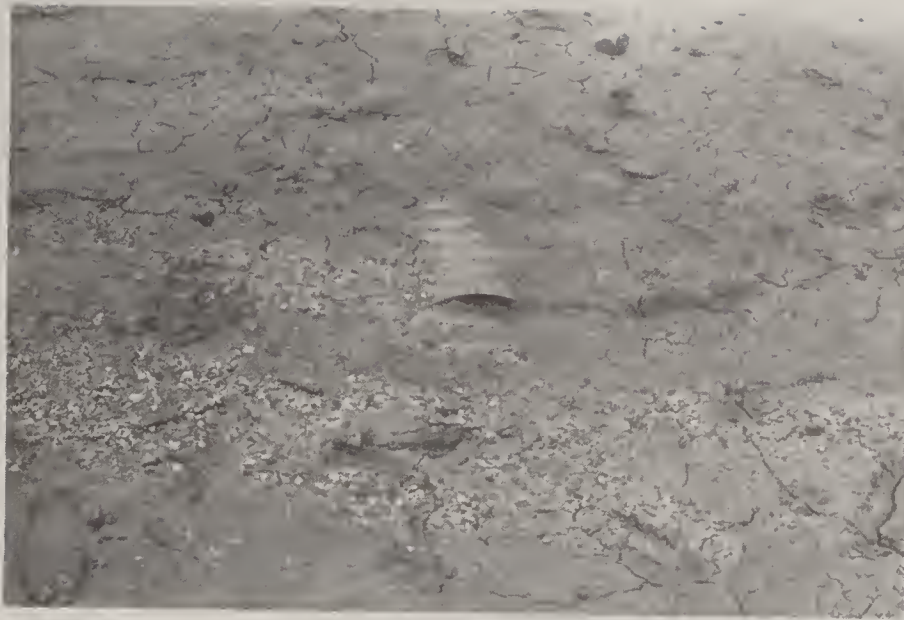
Photo 1-17: Culvert through highway near Window Rock, Arizona completely filled by sediment.

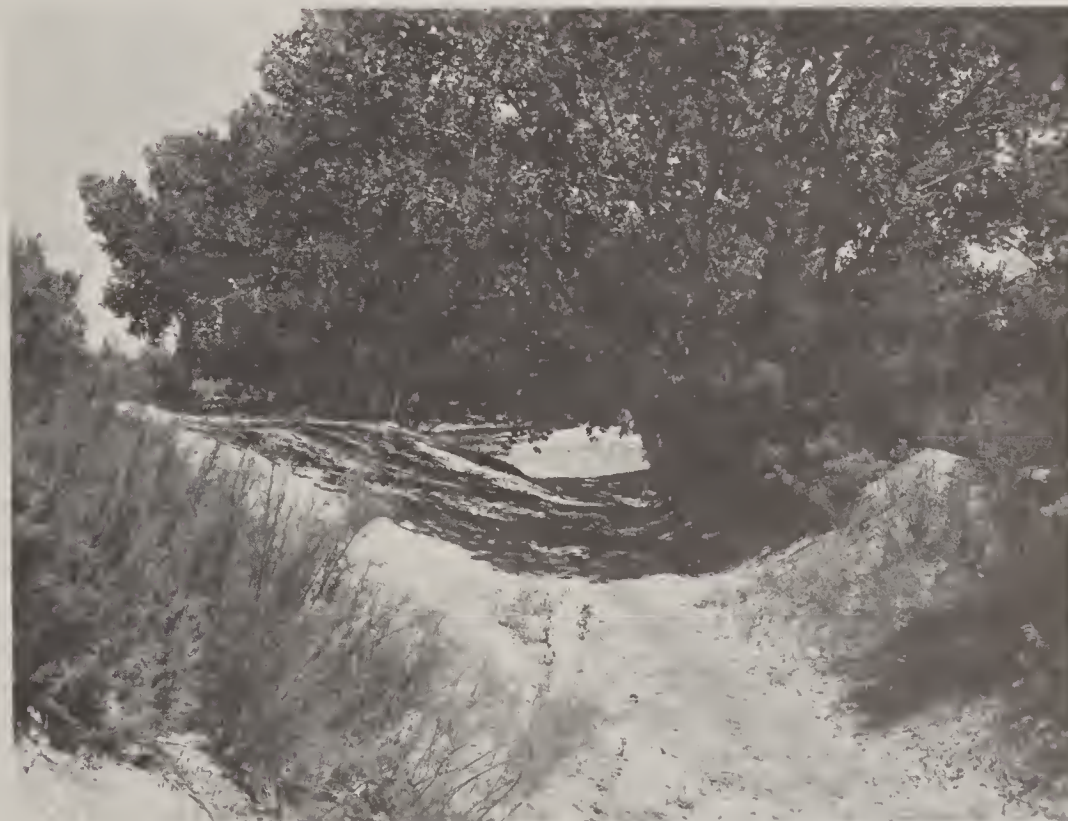
Photo 1-18: Sediment deposited about 6 miles upstream of Polacca Dam No. 2. Prior to deposition, channel was about 30 to 40 feet deep.

Beneficial effects of sediment deposition may occur when sediment is deposited in incised channels. The sediment reduces streambank erosion and induces vegetative growth. Examples include Dead River and Leroux Wash where deposition is naturally occurring as a result of aggradation. Also on Polacca and Wepo Washes due to the construction of structures which have caused sediment deposition in deeply incised arroyos for a distance of several miles upstream (Photo 1-18).

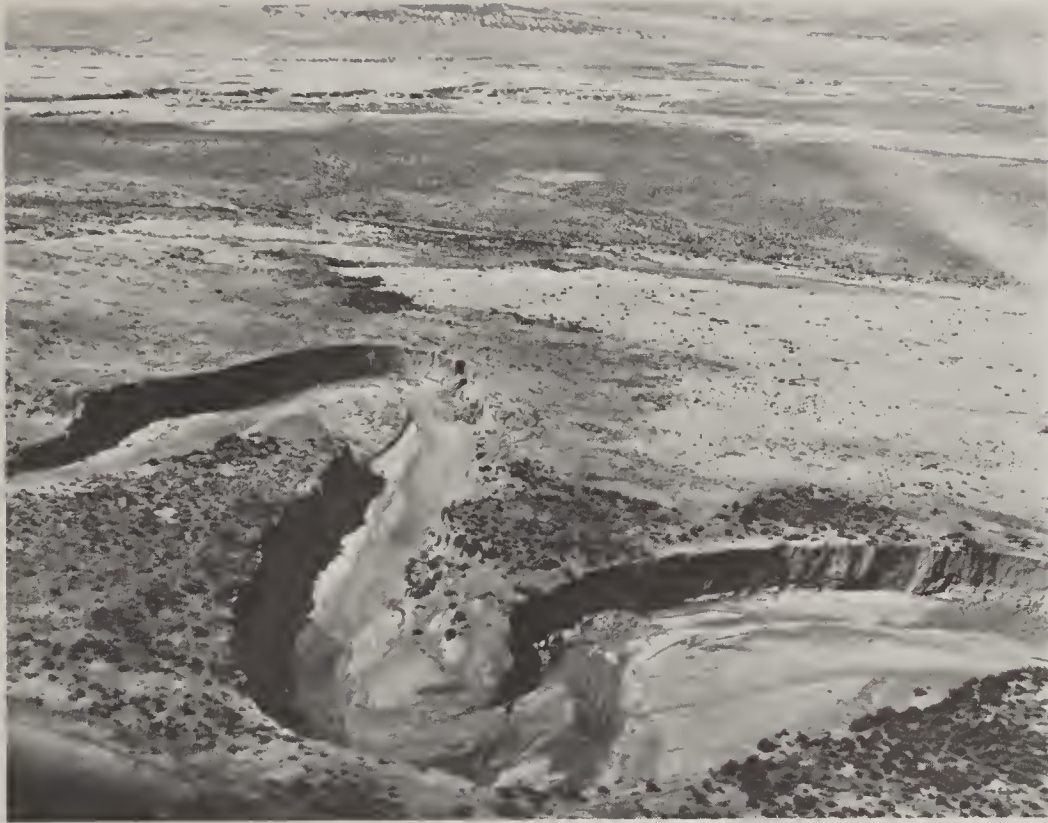
Photo 1-19: Puerco River, Apache County, Arizona. Aerial view of trenched valley.

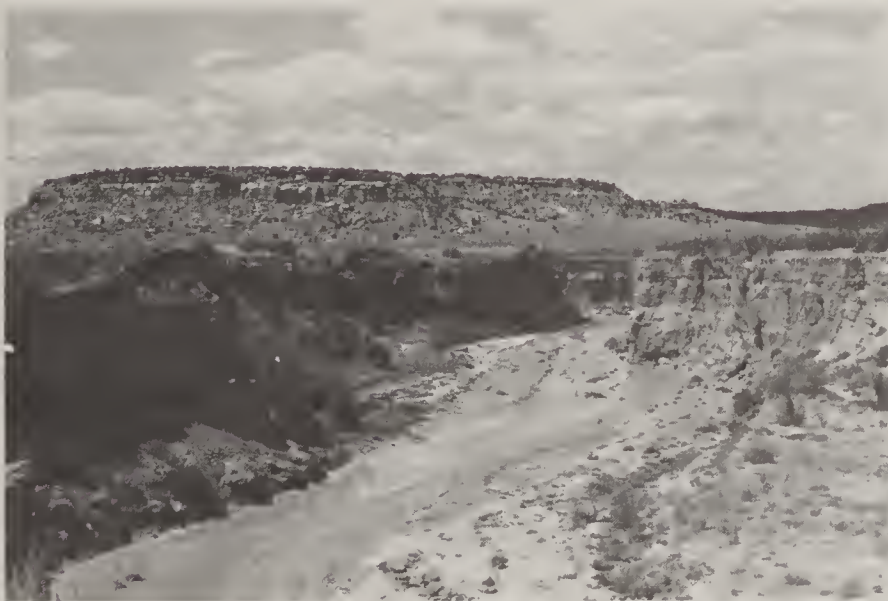
Photo 1-20: Polacca Wash, Navajo County, Arizona. Ground view of trenched valley.

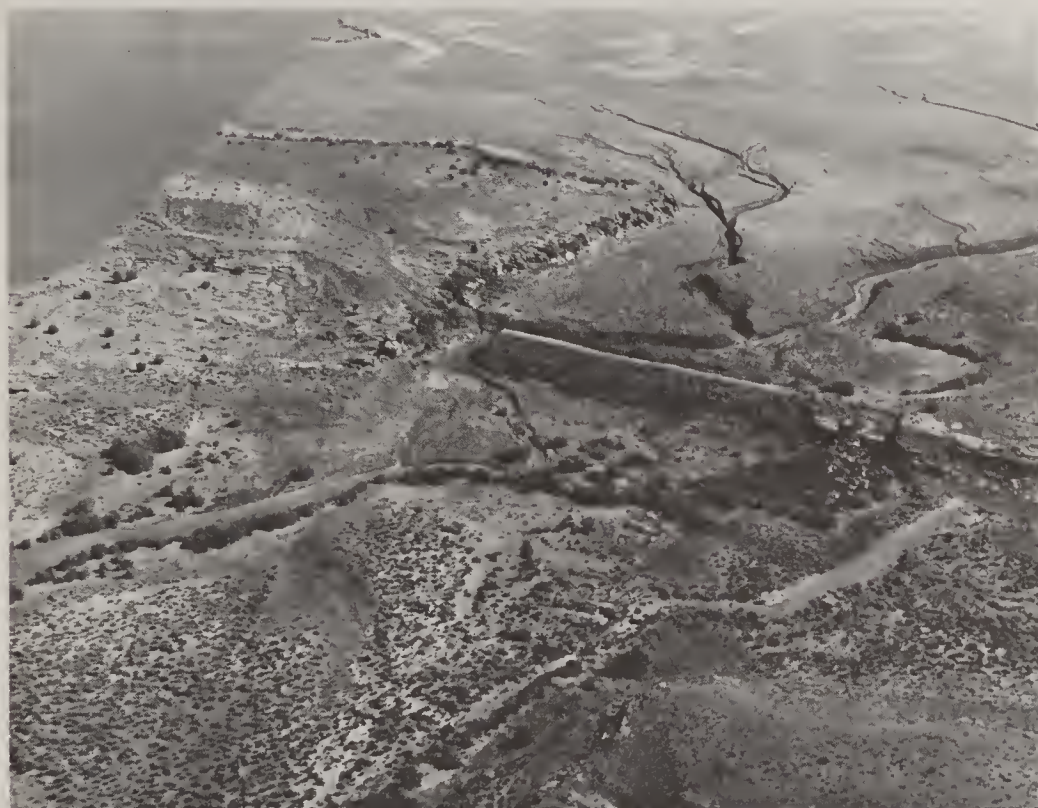
Photo 1-21. Zion Dam, Apache County, Arizona. Aerial view looking east (upstream) showing failed dam and sediment. The dam failed in 1973; repaired in 1979.

completed in 1919 and stood until failure in 1973; the present dam was completed in 1979. Studies made by the U.S. Bureau of Reclamation (1955) show that in the 44 year period (1908-1952) about 22,700 acre-feet of sediment have been deposited above Zion Dam. The dam has caused sedimentation as far upstream as the U.S. Highway 666 crossing over Carrizo Wash, which is about 11 miles upstream from the dam and 80 feet higher than the elevation of the dam spillway.

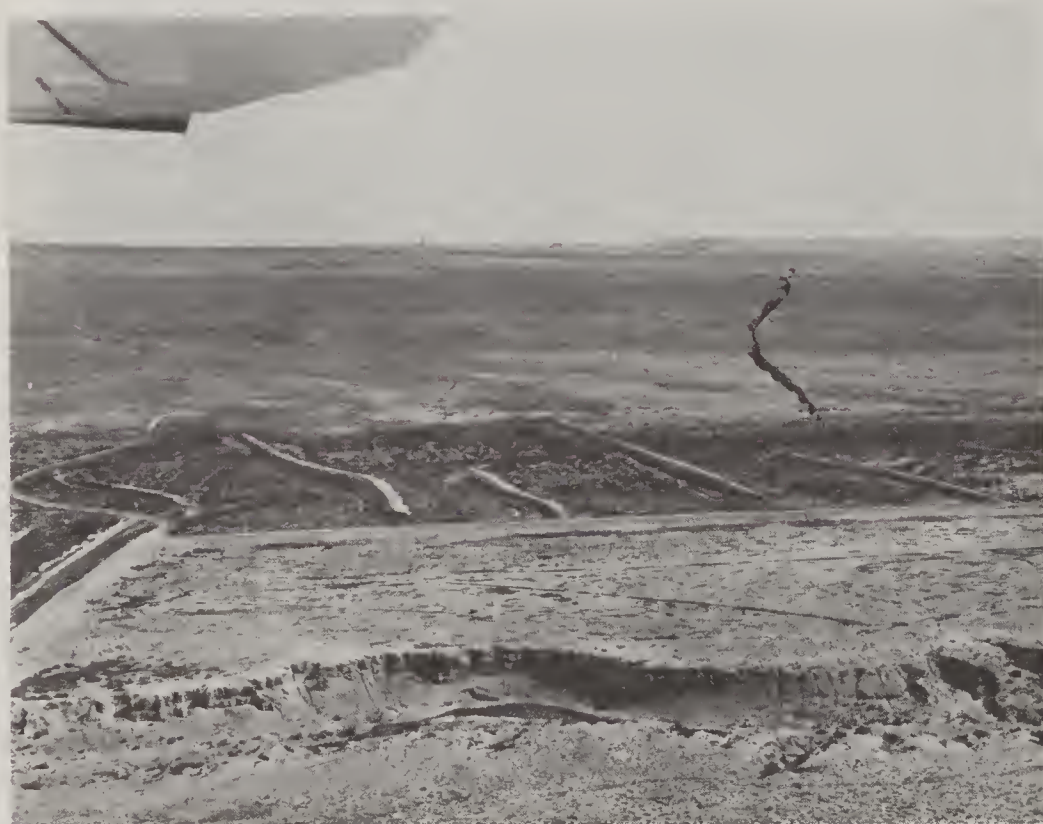
Photo 1-22. Polacca Wash Dam No. 2, Hopi Indian Reservation, Navajo County, Arizona. Aerial view looking southeast showing Polacca Wash downstream of dam. Main dam to left of photo. Dikes in center are bays in the emergency spillway.

Another structure is Polacca Wash Dam No. 2, located across Polacca Wash on the Hopi Indian Reservation about six miles southwest of the Village of Polacca, Navajo County, Arizona. Between about 1900 and 1945 the channel of Polacca Wash eroded to a depth of about 40 feet near Polacca (Hadley, 1963). In the years 1945 to 1953, three dams, designated as Numbers 1, 2 and 3 (Hadley), were constructed on Polacca Wash and another near the mouth of Wepo Wash. The purpose of these structures was to direct flood flows out for water spreading over the valley floor and to induce deposition of sediment in the channel.

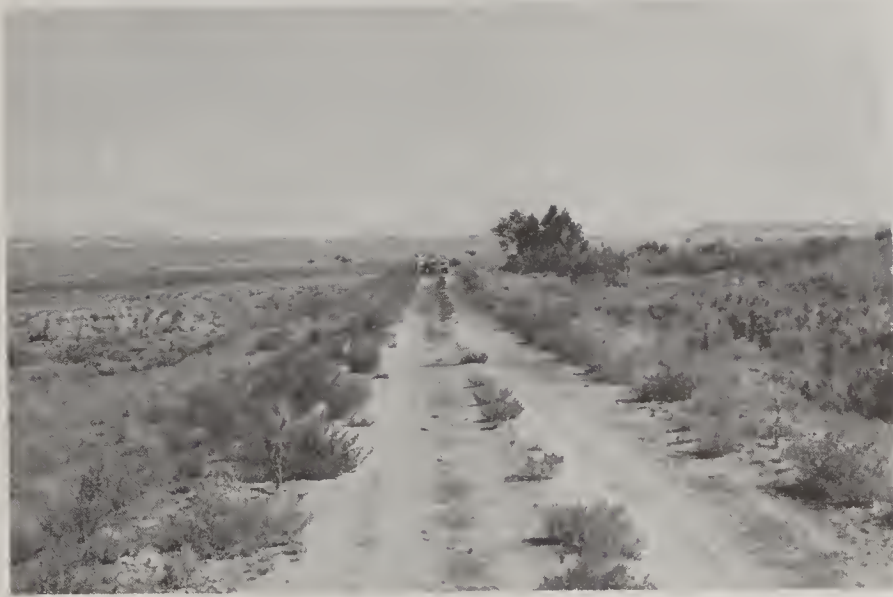
Photo 1-23. Polacca Wash Dam No. 2, looking northeast along crest of dam. Sediment has almost completely filled reservoir area, right of photo.

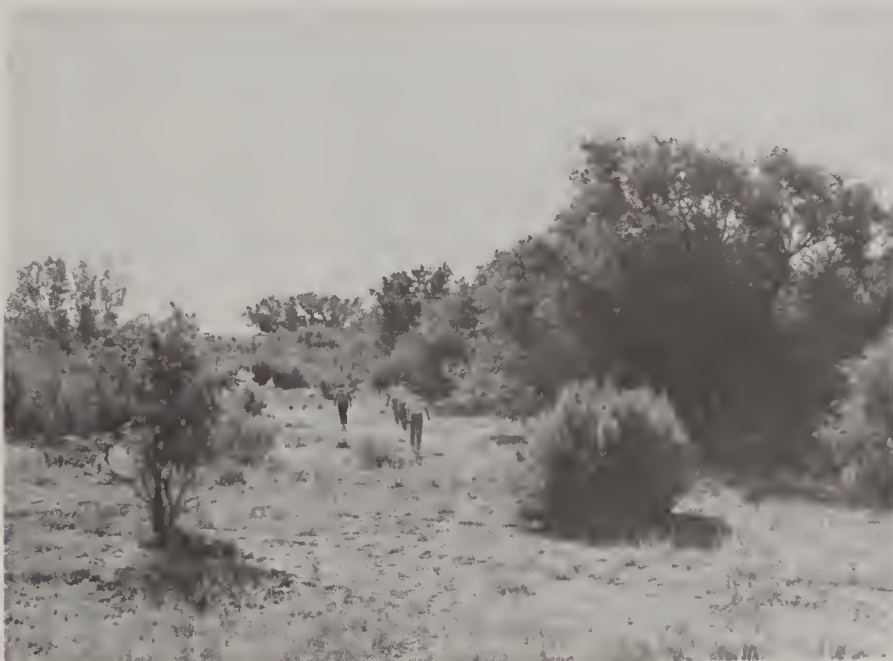
Photo 1-24. Polacca Wash Dam No. 2. View showing vegetative growth on upstream floodplain.

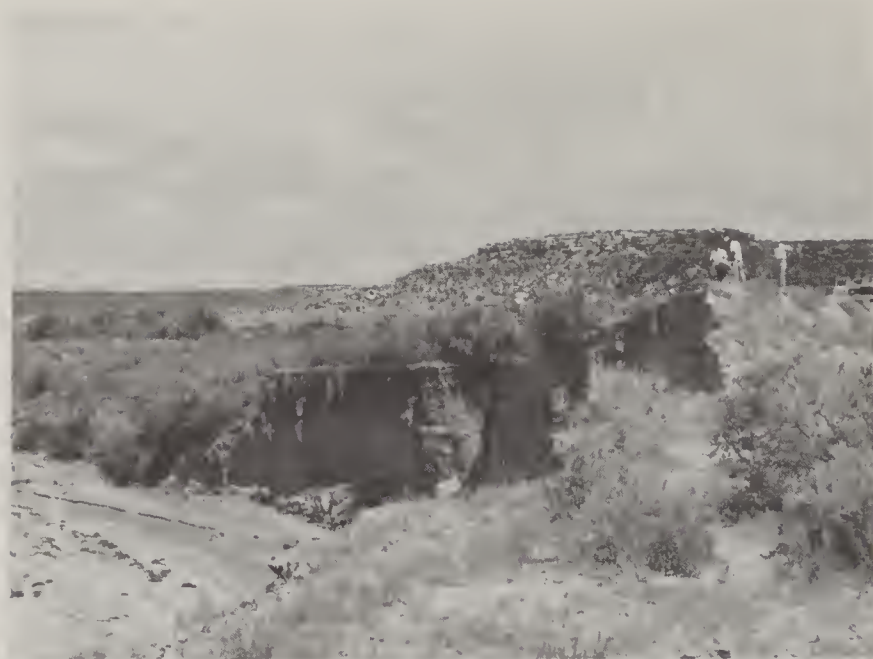
Photo 1-25. Polacca Wash Dam No. 1. View is looking upstream showing failed dam. The people and vehicle are on the crest of the dam.

Polacca Dam No. 1, the upper dam, was completed in 1953 and is located just below the confluence of Polacca Wash with Burnt Corn Wash and Low Mountain Wash. Hadley (1963) reports that the channel has been completely filled above the structure for a distance of 2,300 feet and channel deposits extend upstream for 7,500 feet. USDA visited this site in 1979. The dam has been breached (see Photo 1-25) and is no longer functional.

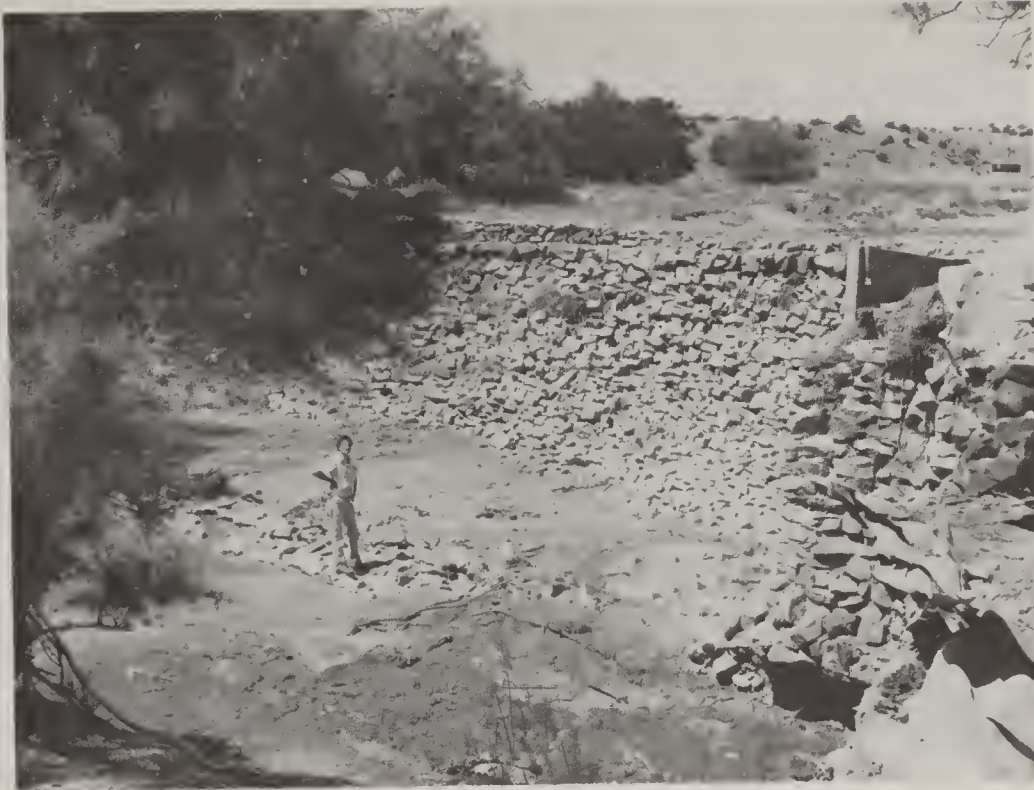
Photo 1-26. Figueredo Wash (San Juan River Basin). Grouted rock drop structure constructed by CCC. View is looking upstream.

Examples of the value of large grade stabilization structures are the two grouted rock drop structures installed on Figueredo Wash at Mexican Springs, New Mexico, about 20 miles north of Gallup, New Mexico. The site is within the San Juan River Basin; however, it is only a few miles east of the boundary of the Little Colorado River Basin. Conditions are similar to those within much of the Basin. In 1936, the CCC constructed these structures to direct flows onto range test plots as part of the Mexican Springs Experimental Station (Hubbell and Gardner, 1950). Both structures are still intact (see Photos 1-26 and 1-27). They have been very successful in stabilizing the channel and promoting vegetative growth (see Photos 1-28 and 1-29).

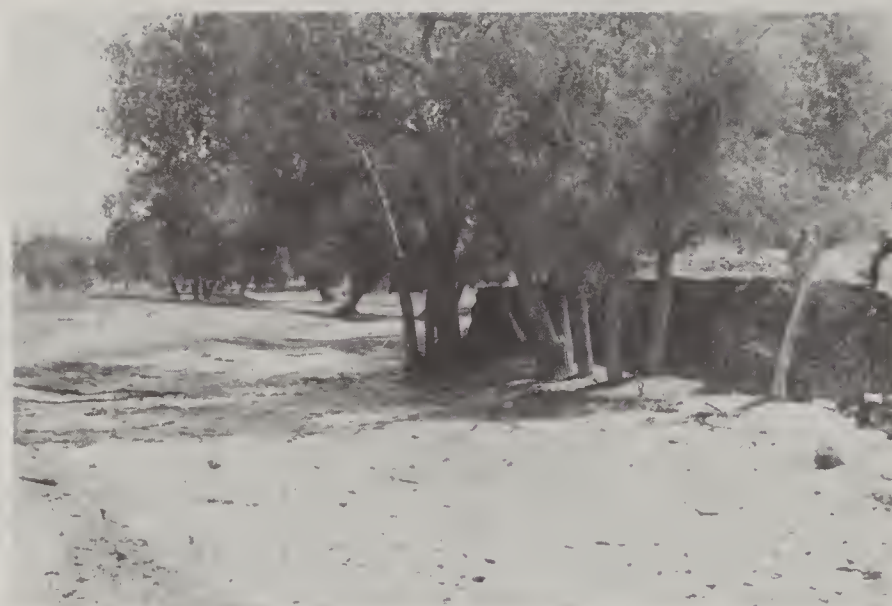
Photo 1-28. Figueredo Wash. View is looking upstream showing sediment deposits and vegetative growth resulting from drop structure. This structure is the same as the one shown in Photo 1-27.

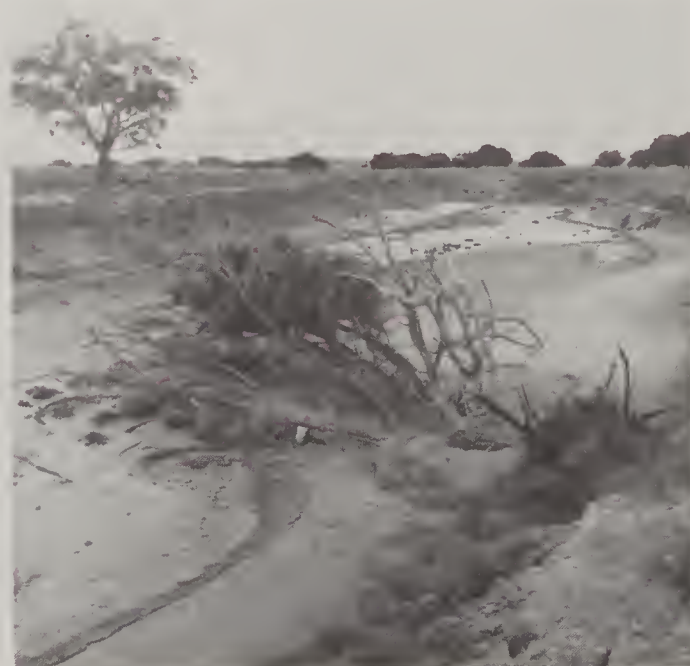
Photo 1-29. Figueredo Wash showing trenched alluvial valley. This reach is about two miles downstream of the drop structure shown in Photo 1-26.

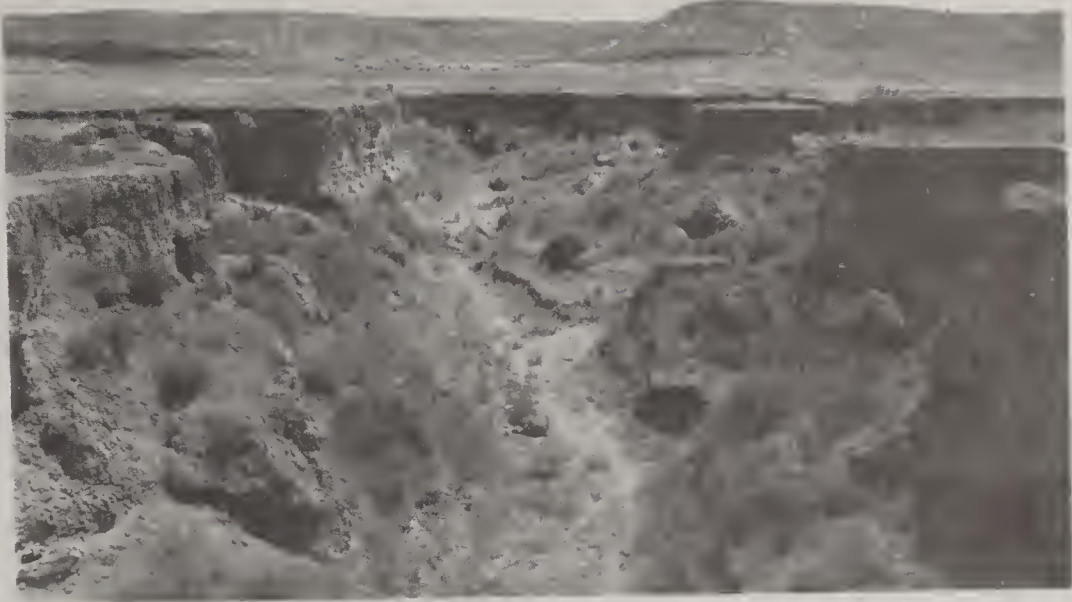
Photo 1-30. Active Headcut, Tze Chizzi Wash, Low Mountain Trading Post, Navajo County, Arizona

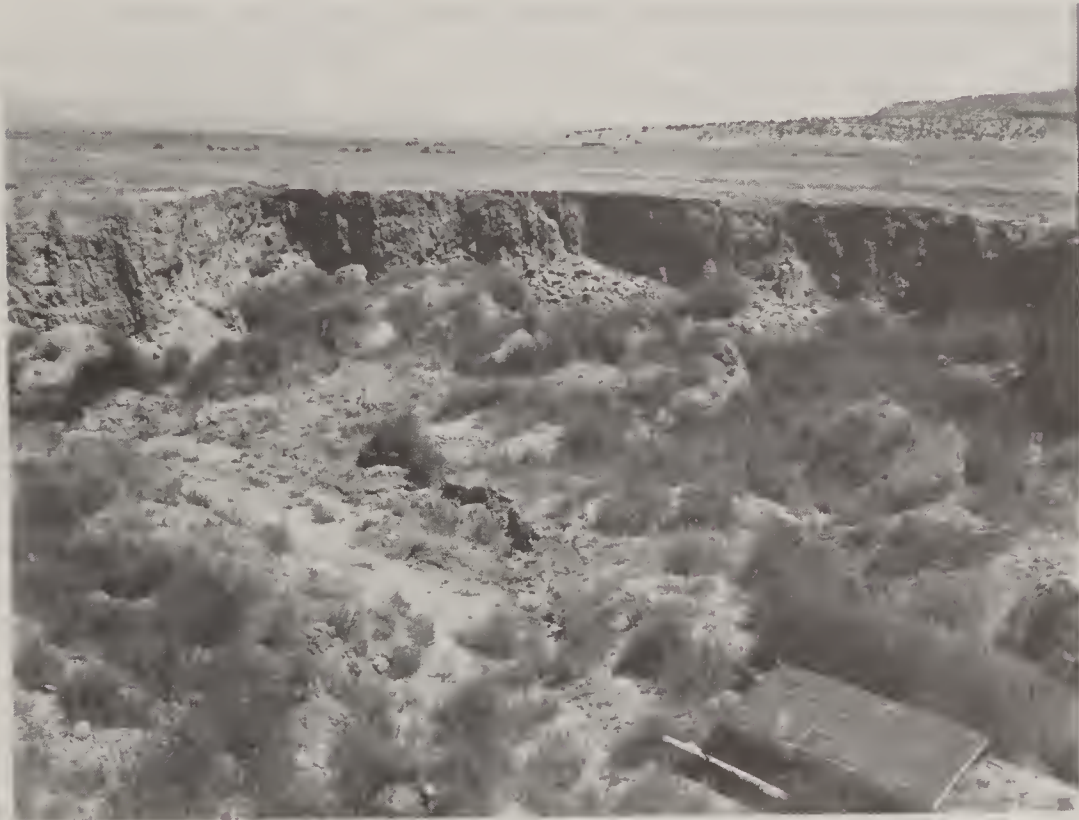
Photo 1-31. Active Headcut, Tze Chizzi Wash, Low Mountain Trading Post, Navajo County, Arizona.

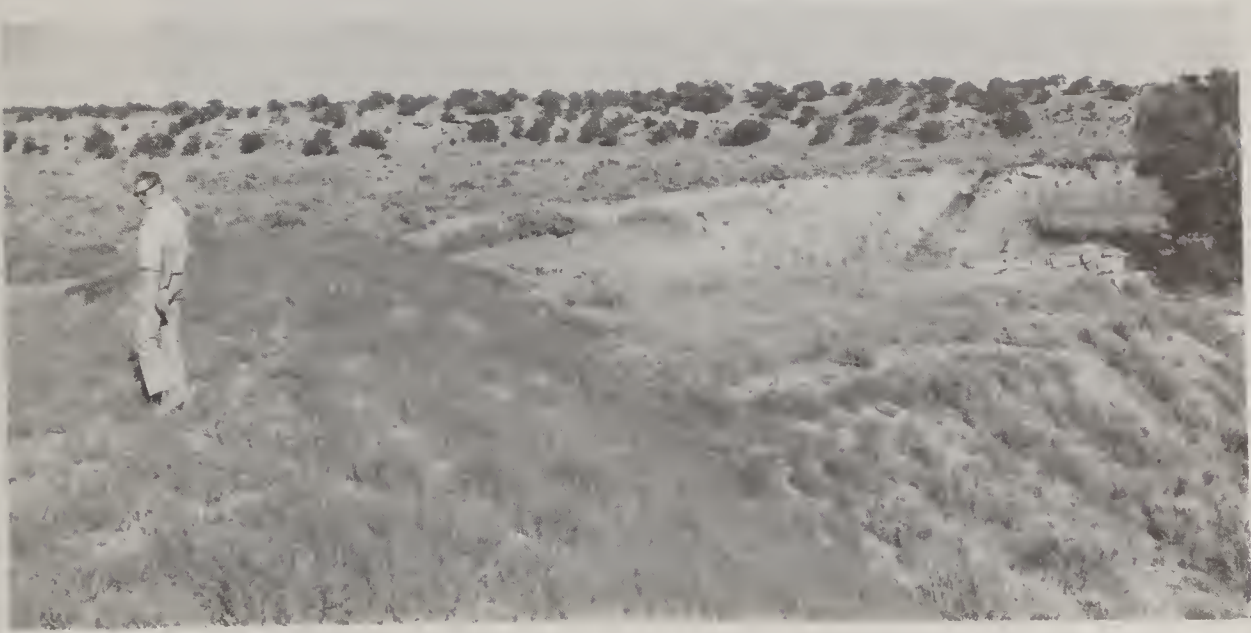
Photo 1-32. Failed water spreader dike, Steamboat Wash, Navajo Indian Reservation, Apache Canyon, Arizona. This structure could be repaired and a rock spillway provided at minimal expense.
